السيد المستشار/رئيس هيئة النيابة الادارية

اهمال الدير الأبيض بسوهاج وانهيار أجزاء من الجدار الشمالي

الدير الأبيض - دير الأنبا شنودة - في سوهاج تقرير عن إدارة وتطوير المنطقة 2010

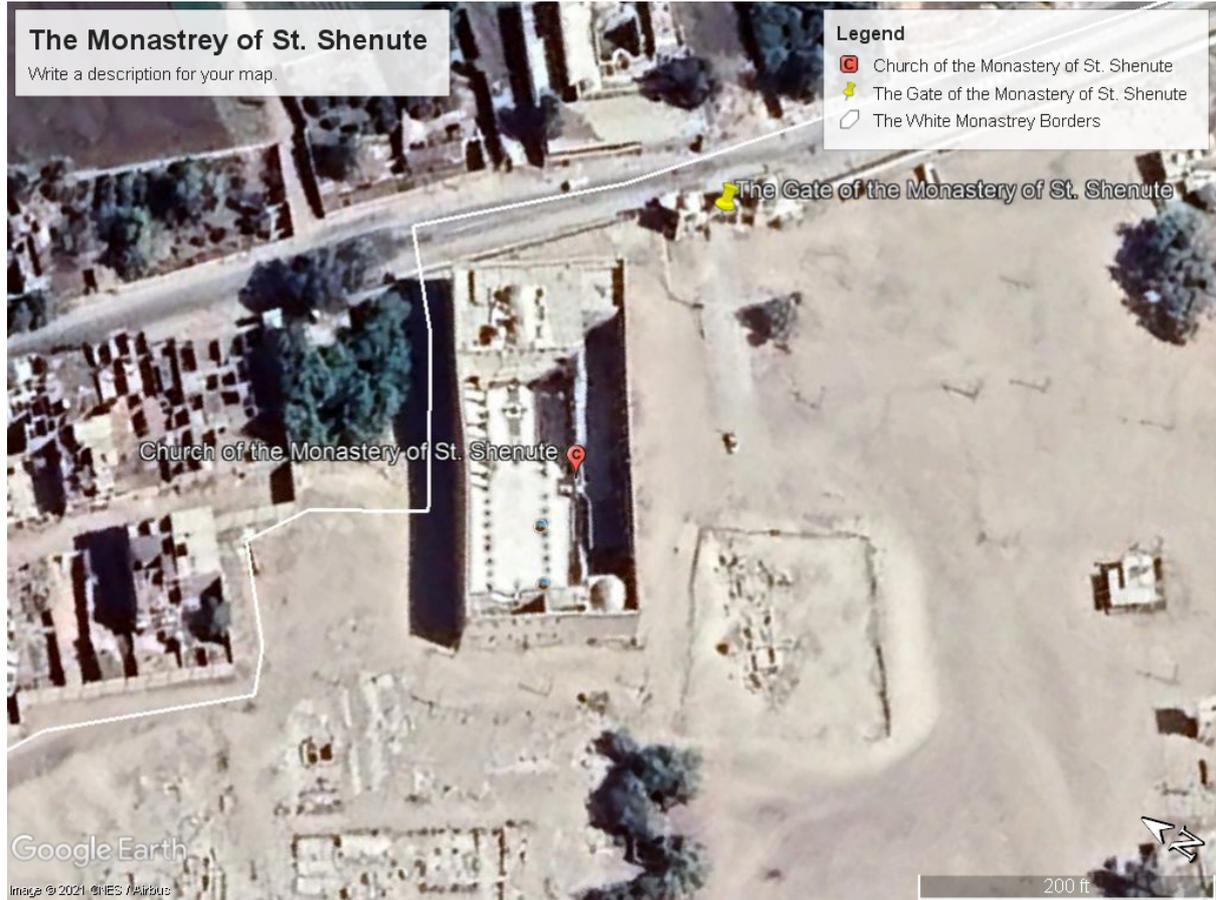
٣. صورة توضح الكنيسة الأثرية ومكان انهيار جدار الصحن الاثري

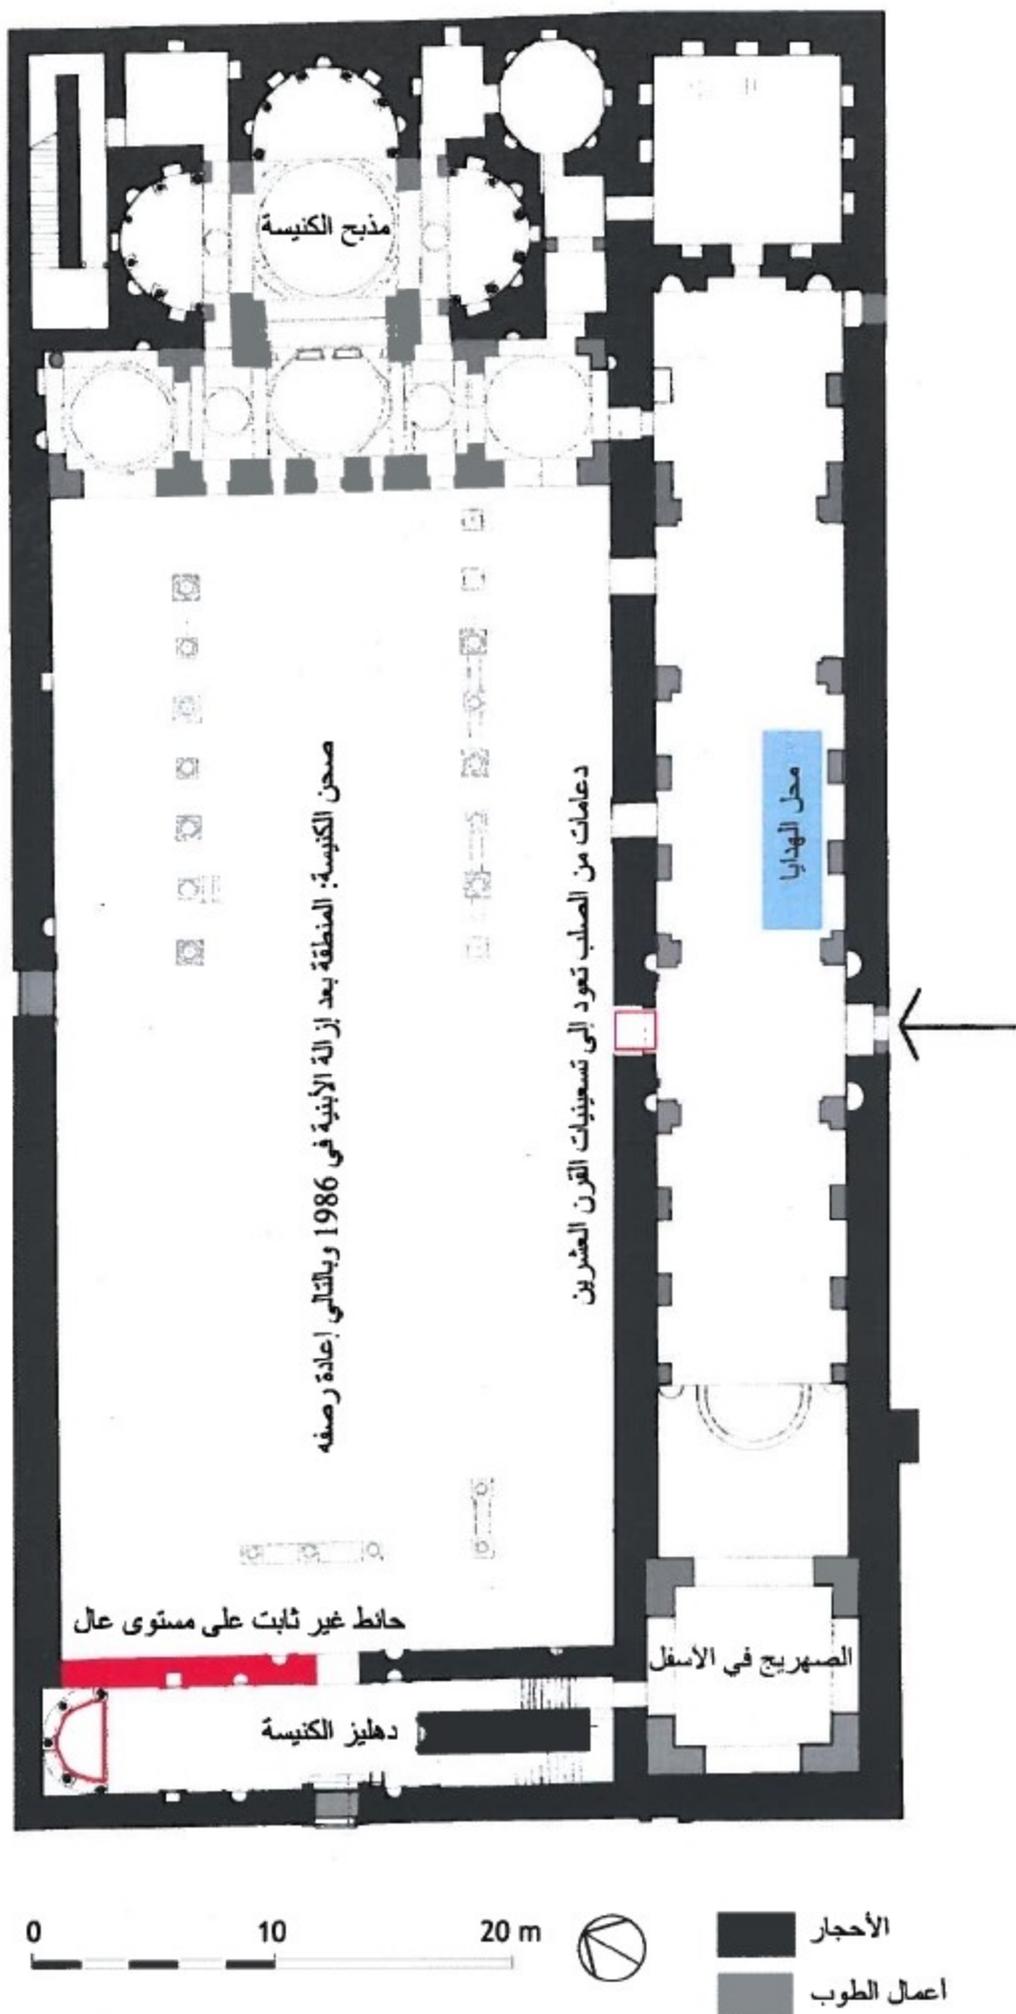
شكل 14: خريطة تظهر فيها حالة الكنيسة (حسب دار مشتاد)

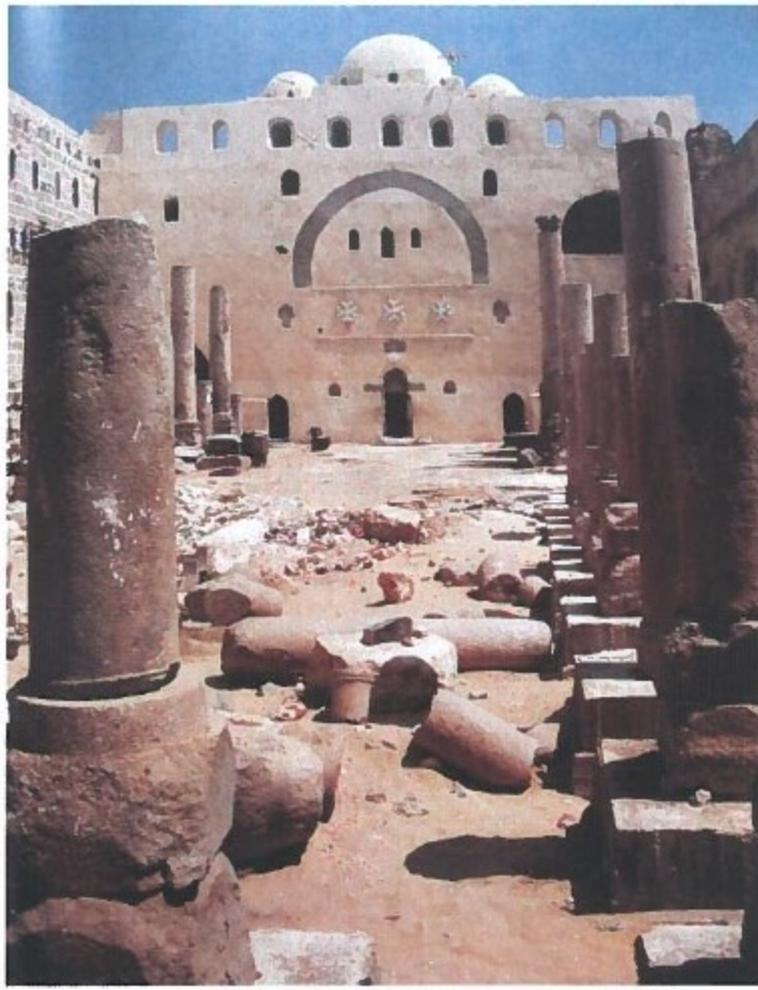
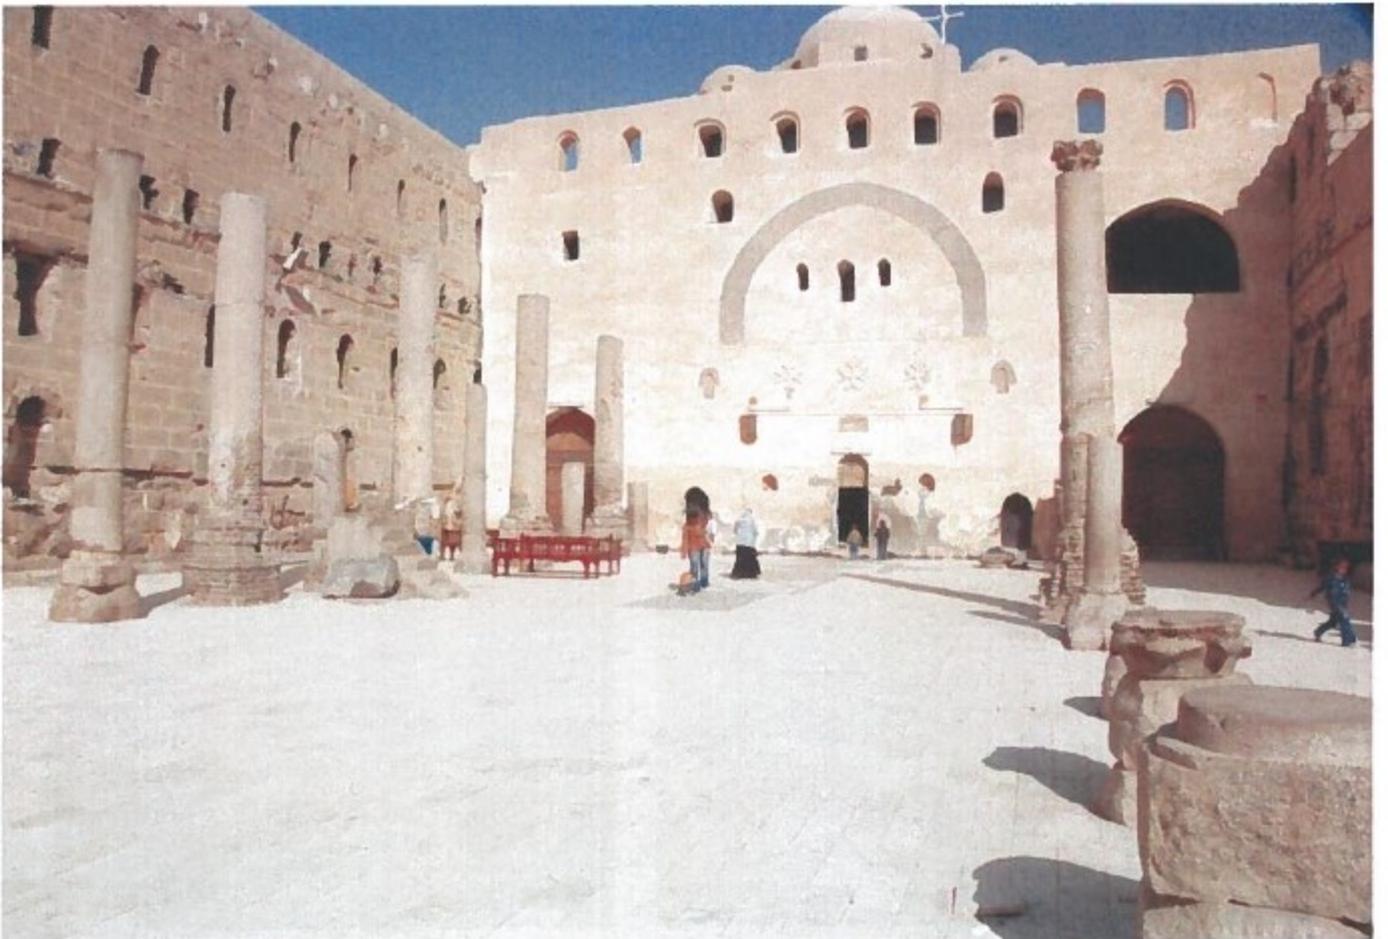
شكل 15: الصحن قبل وبعد التمهيد (صور قبل 1986 و 2009)

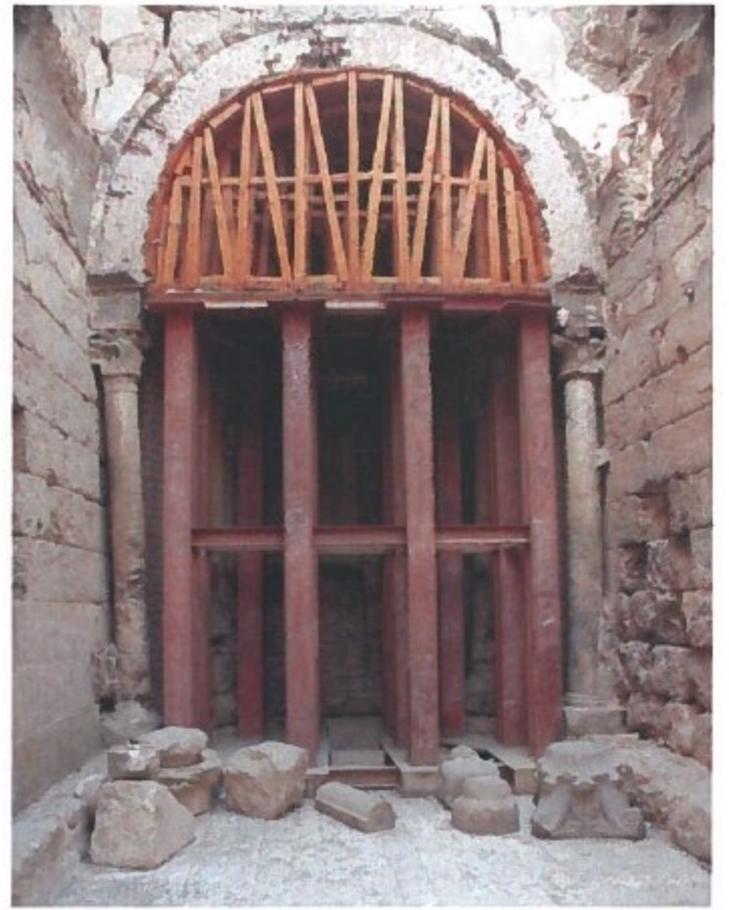
شكل 16: دهليز الكنيسة قبل وبعد التدعيم (تصوير: سي شرودر 1997 ون. وارنر 2009)، تيجان الأعمدة المنفصلة في الدهليز والباب الغربي المسدود (تصوير: ن. وارنر 2009)

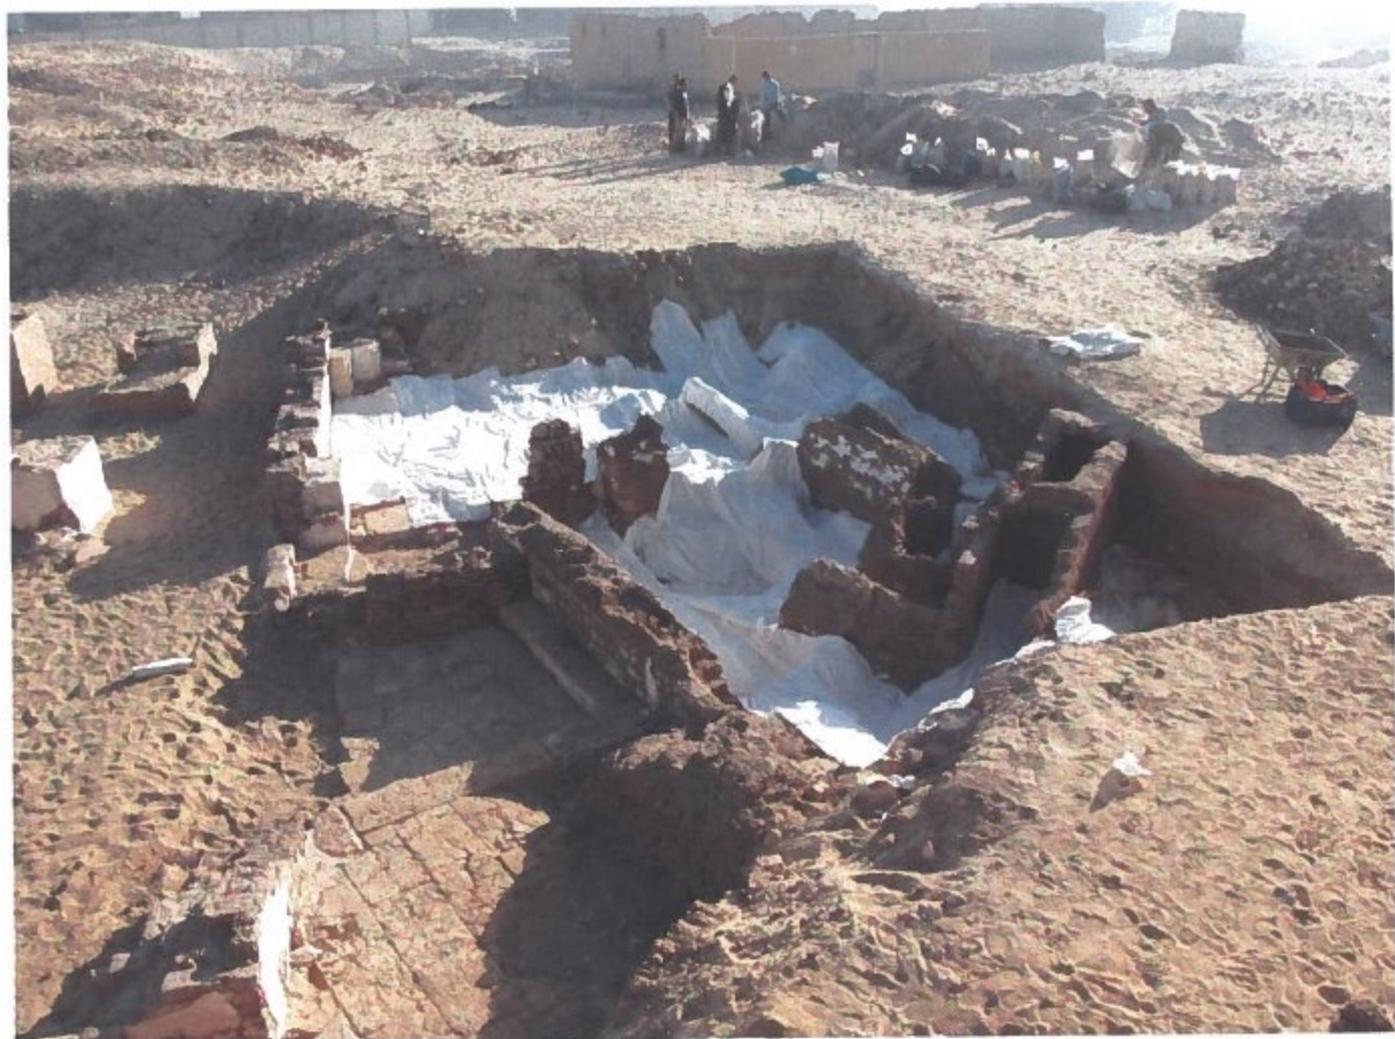
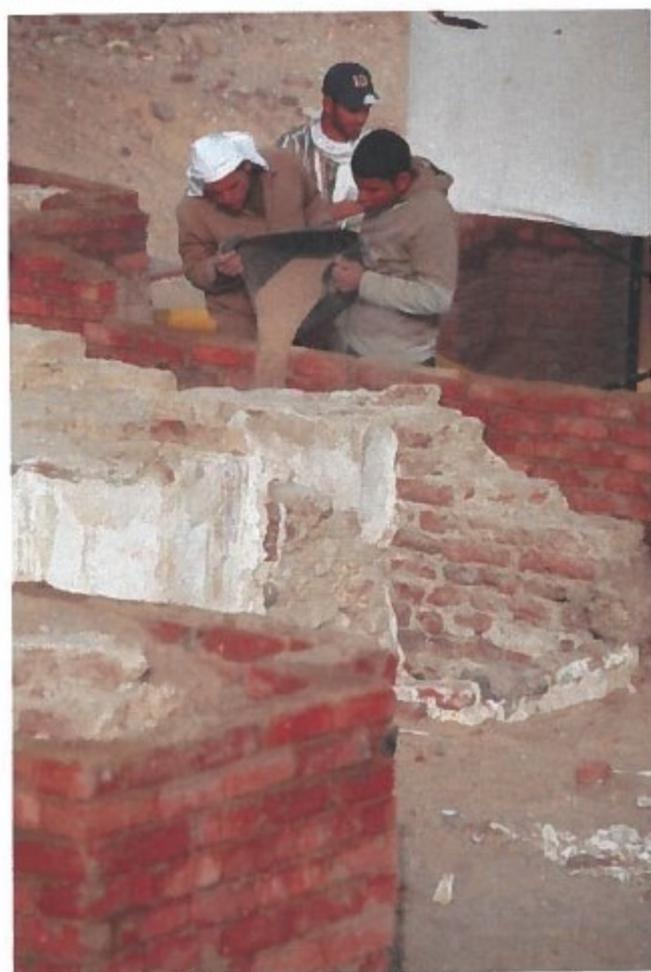
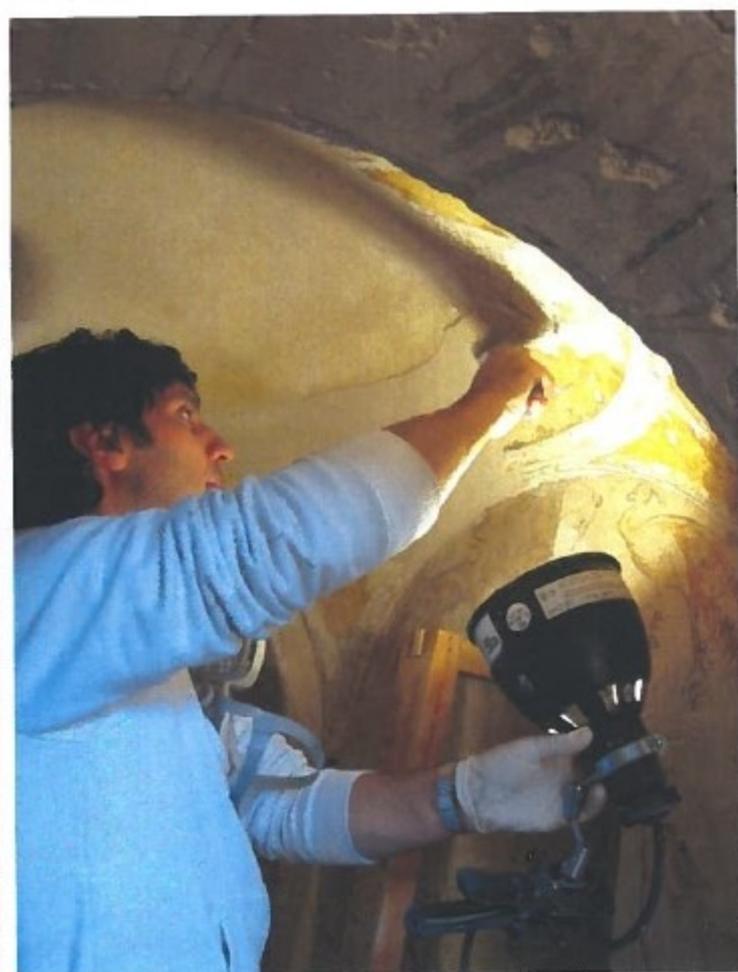
شكل 19: ترميم مقبرة القديس شنودة، وإعادة ردم منظمة، والحوائط الوقائية (تصوير: جي بايك 2009)

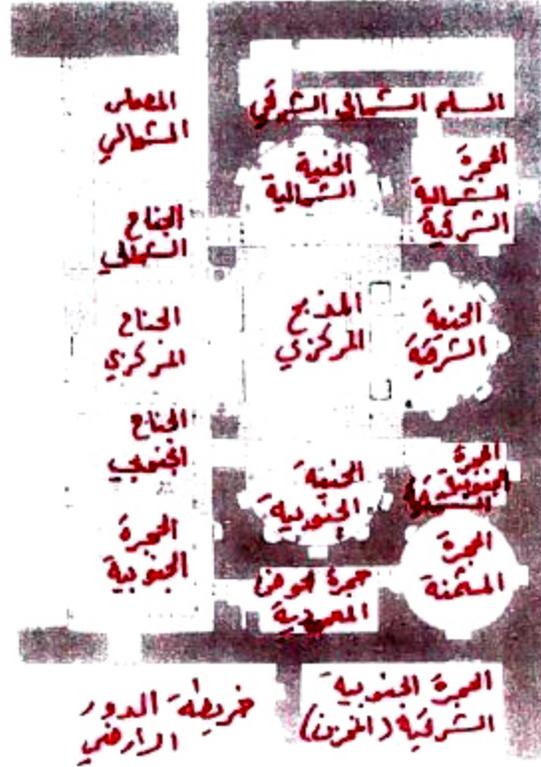
[شكل 1. الناحية الشرقية للكنيسة، الدور الأرضي، حيث تظهر المصطلحات المستخدمة في التقرير.]

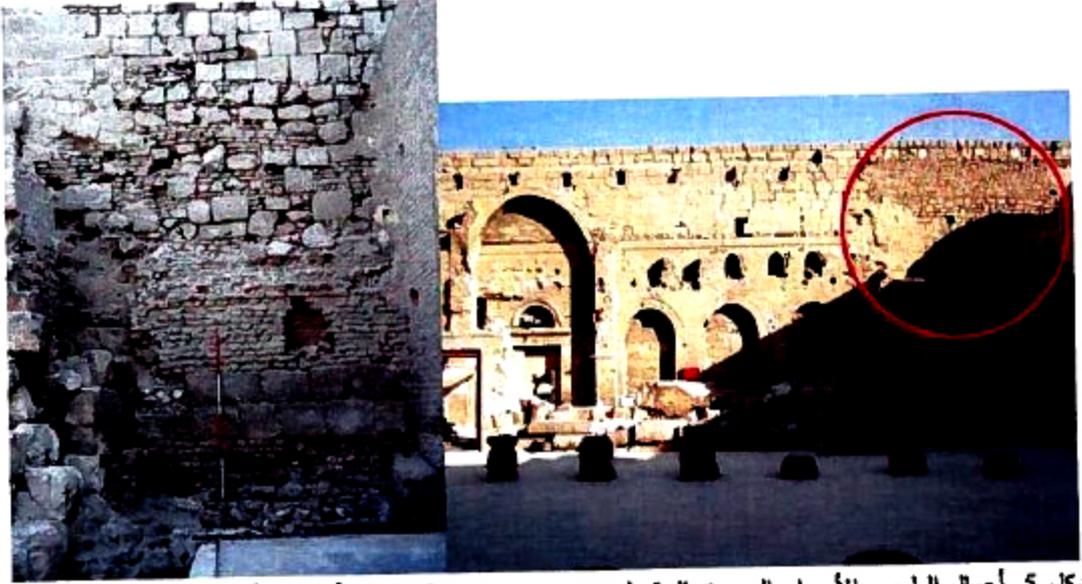
شكل 5. أعمال الطوب والأحجار المهذدة بالسقوط
 شكل 6. أعمال الأحجار المهذدة بالسقوط
 (في الجانب الأيمن الداخلي، بجوار وفوق الغرفة المقبية).] في واجهة الحائط الجنوبي]

إلى أن تكتمل الإصلاحات، يجب بناء سور حول هذه المنطقة لحماية الجمهور من الخطر. وفي داخل الصحن، يجب أن يكون هذا السور على بعد 7 أمتار، على الأقل، من الحائط المهدد بالسقوط. كما يجب إغلاق الجزء الشمالي من الدهليز، إغلاقاً تاماً، بسور حتى تنتهي أعمال الإصلاحات. يجب القيام بهذه الأشياء على الفور. انظر شكل 4.

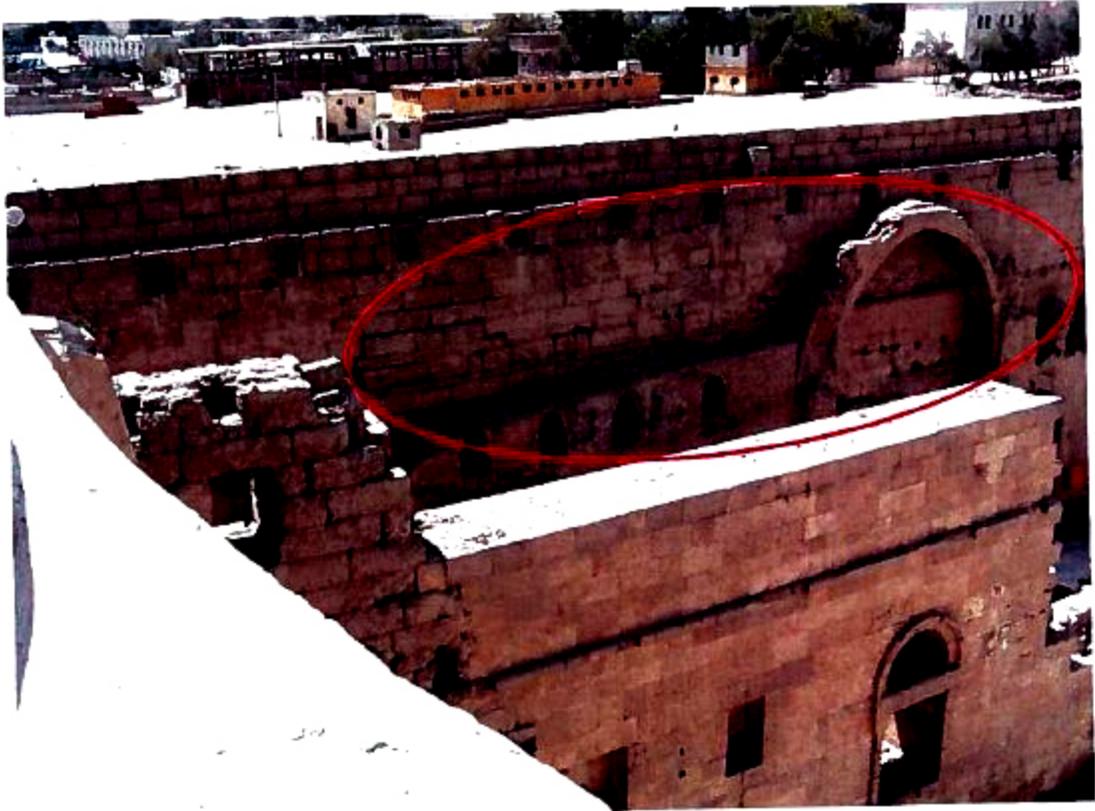
[شكل 7. بقايا القبر في الوجه الداخلي للجدار الجنوبي، بما في ذلك القوس بداخل الدائرة الحمراء]

3. يجب القيام بإصلاح بقايا القبو الحجري، بما في ذلك قوس القبو الحجري الموجود فوق المدخل، الذي ينفصل عن الحائط الخارجي (انظر شكل 7). تحت إشراف مهندس معماري متخصص في التعامل مع المباني الأثرية، يجب إصلاح أعمال المباني الطوب المتهاكمة بفعل عوامل التعرية، وربطها مرة أخرى بالحائط القديم. يجب تركيب سقالة وفحص أعمال الطوب التي تعود للعصور الوسطى لتحديد نوع الإصلاح المطلوب بدقة. ومن المحتمل أنه يجب ربط أعمال الطوب بالحائط الغربي الأصلي؛ وهذا عن طريق إدخال قضبان صلب في حشوة مونة مصنوعة من الأسمنت الناعم، من خلال

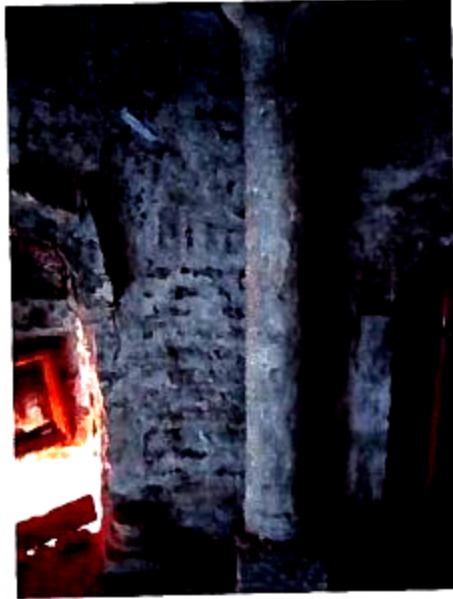
شكل 8. شرخ كبير في الحنيه الشمالي.

4. يجب لحم الشروخ الكبيرة في الحنيه الشمالي (انظر شكل 8)، تحت إشراف مهندس معماري متخصص في التعامل مع المباني الأثرية، عن طريق إزالة الطوب أو الأحجار من الشروخ، ووضع مونة جيرية ثم وضع الطوب أو الأحجار مرة أخرى لتشكيل رابطة عبر الشرخ.

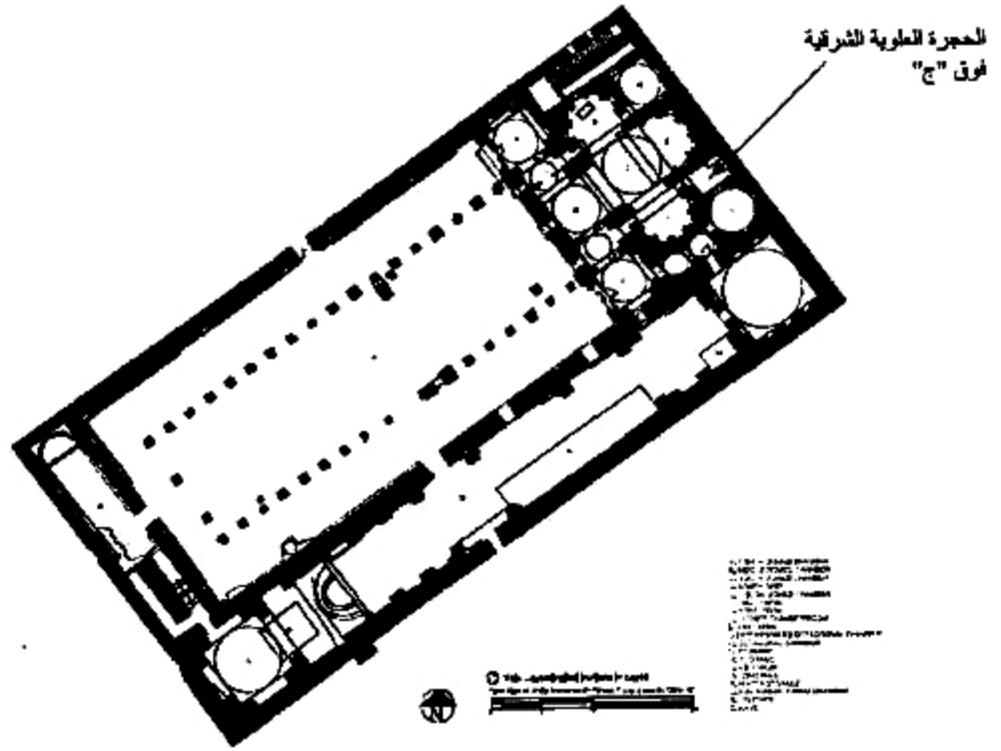
إشكال 9. الناحية الشرقية من الكنيسة، حيث تظهر الغرف التي تحتاج شروخها إلى ملئها بمونة جيرية.

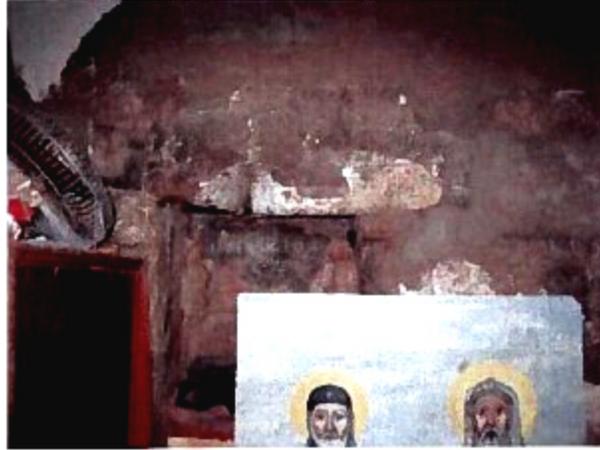
[شكل 10. العتبة المكسورة في التجويف الجنوبي للحجرة الشمالية الشرقية.]

6. في الحجرة الشمالية الشرقية، يجب إصلاح العتبة المكسورة في تجويف الحائط الجنوبي (إشكال 10)، تحت إشراف مهندس معماري متخصص في التعامل مع المباني الأثرية، يجب صلب جزئي العتبة باستخدام الجاك حتى يصبح على مستوى واحد. يجب ملء الشروخ بمونة مكونة من أسمنت بورتلاند عادي ورمل ناعم بنسبة 1:3.

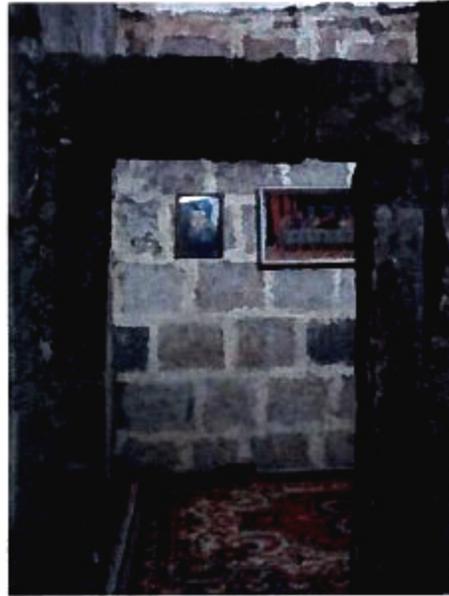
[شكل 11. العتبة المكسورة في الممر المؤدي للسلم الشمالي الشرقي بالدور الأرضي]

7. في الممر المؤدي إلى السلم الشمالي الشرقي بالدور الأرضي (شكل 11)، يجب إصلاح العتبة المكسورة، تحت إشراف مهندس معماري متخصص في التعامل مع المباني الأثرية. يجب صلب الجزء النازل من العتبة باستخدام الجاك حتى يكون في نفس المستوى مع الجزء الآخر، وعندئذ يجب ملئه بمونة مكونة من اسمنت بورتلاند عادي ورمل ناعم بنسبة 3:1.

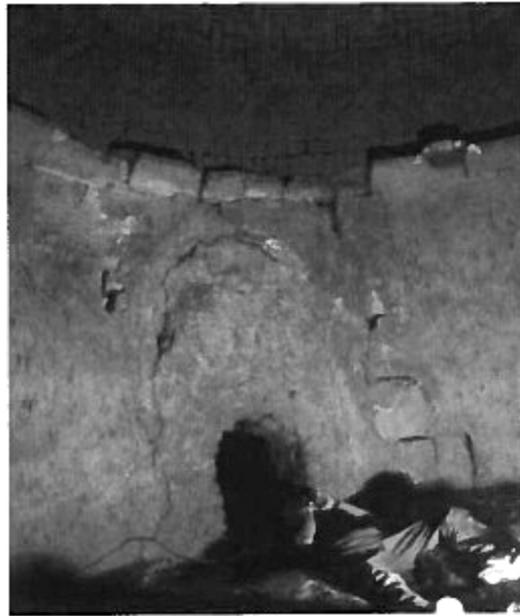
[شكل 12. الحجرة العلوية الجنوبية الشرقية، أعمال المباني الطوب فوق الباب الشمالي]

8. في الدور العلوي، في الحجرة العلوية الجنوبية الشرقية (شكل 12)، يجب القيام بالإصلاحات الآتية: تحت إشراف مهندس معماري متخصص في التعامل مع المباني الأثرية يجب إزالة أعمال المباني الطوب فوق الباب الشمالي والباب الغربي بعناية، وإعادة بنائهما. يجب استخدام مونة جيوية. يجب إصلاح شروخ الحائط الموجود بجانب الباب الشمالي.

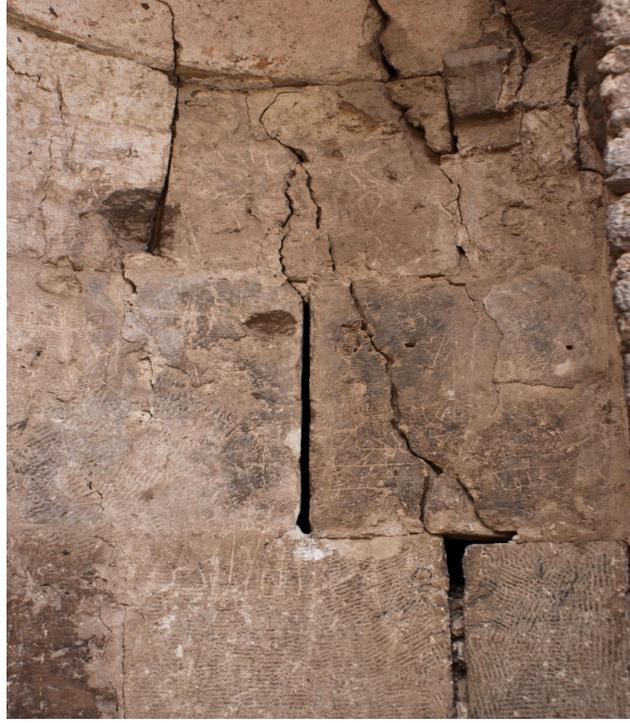
٤. تم اتخاذ هذه الصورة في عام ٢٠١٩ وتوضح حالة الحجر الجيري المستعمل لبناء السور الشمالي للدير الذي دمر جزء منه من ٦ الي ٨ يناير ٢٠٢٢.

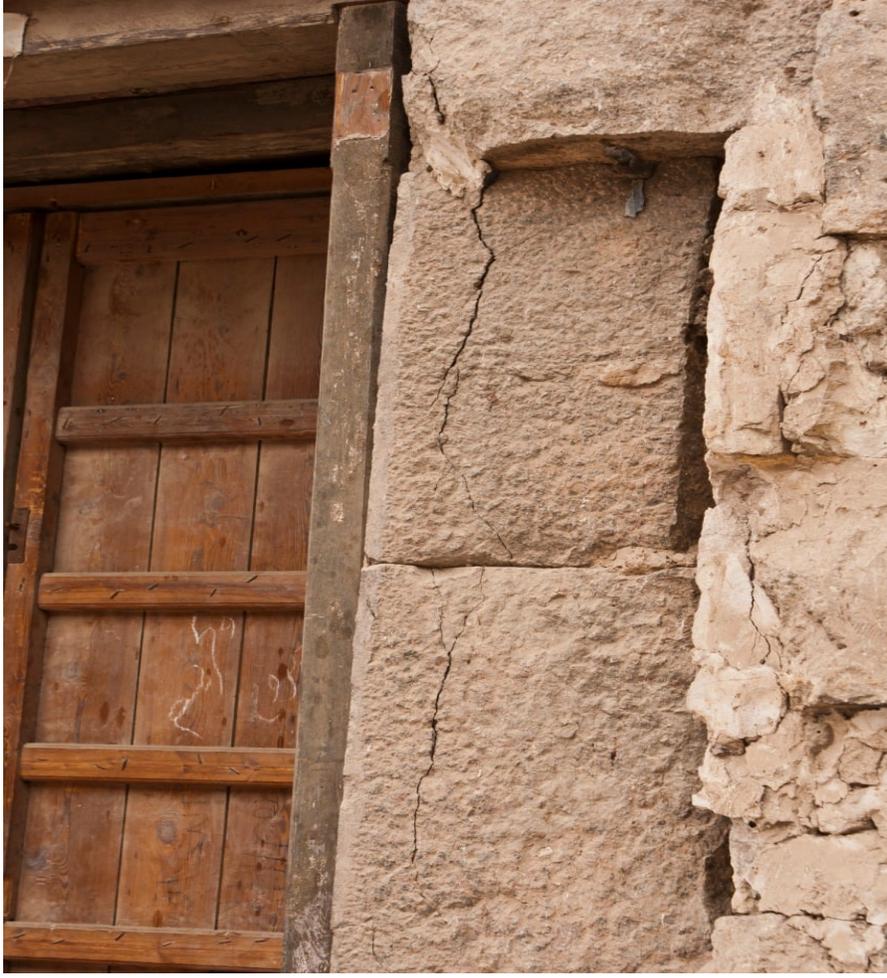
٥. تم اتخاذ هذه الصورة في عام ٢٠١٩ و توضح حالة الحجر الجيري المستعمل لبناء
السر الشمالي للدير الذي دمر جزء منه من ٦ الي ٨ يناير ٢٠٢٢.

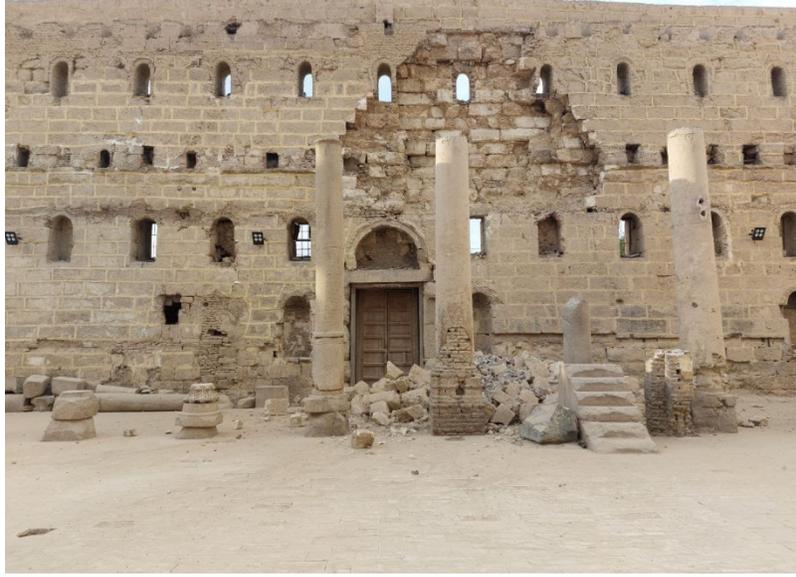
٦. صورہ للجدار الشمالي للدير الابيض موافق ٧يناير ٢٠٢٢ بعد انهياره.

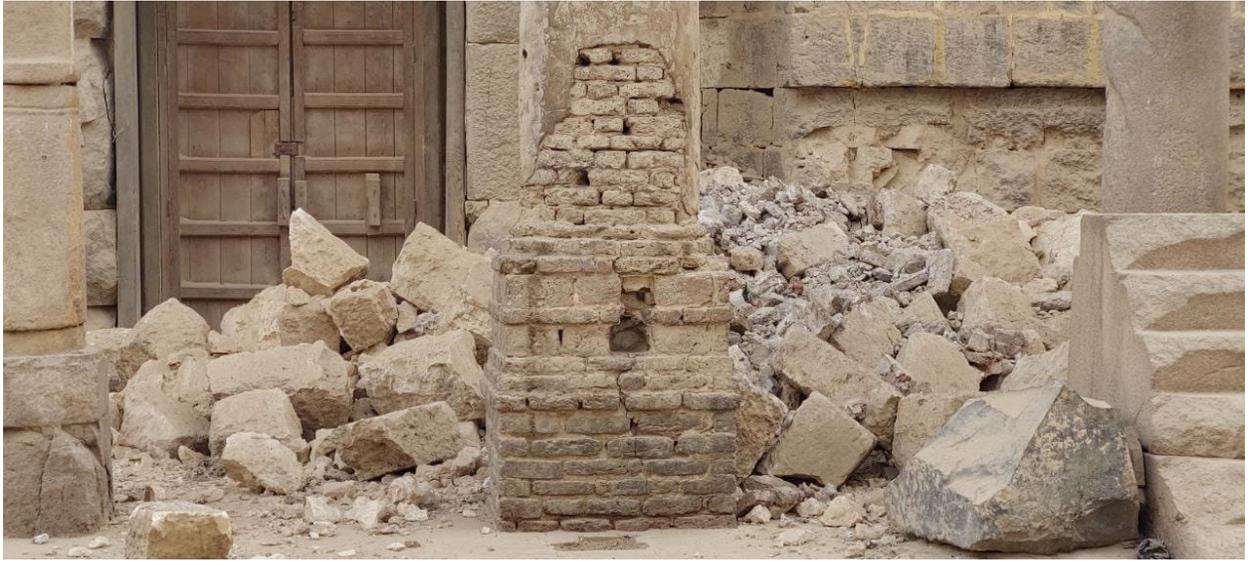
٧. صورہ للحطام بعد انهيار السور بتاريخ ٧يناير ٢٠٢٢.

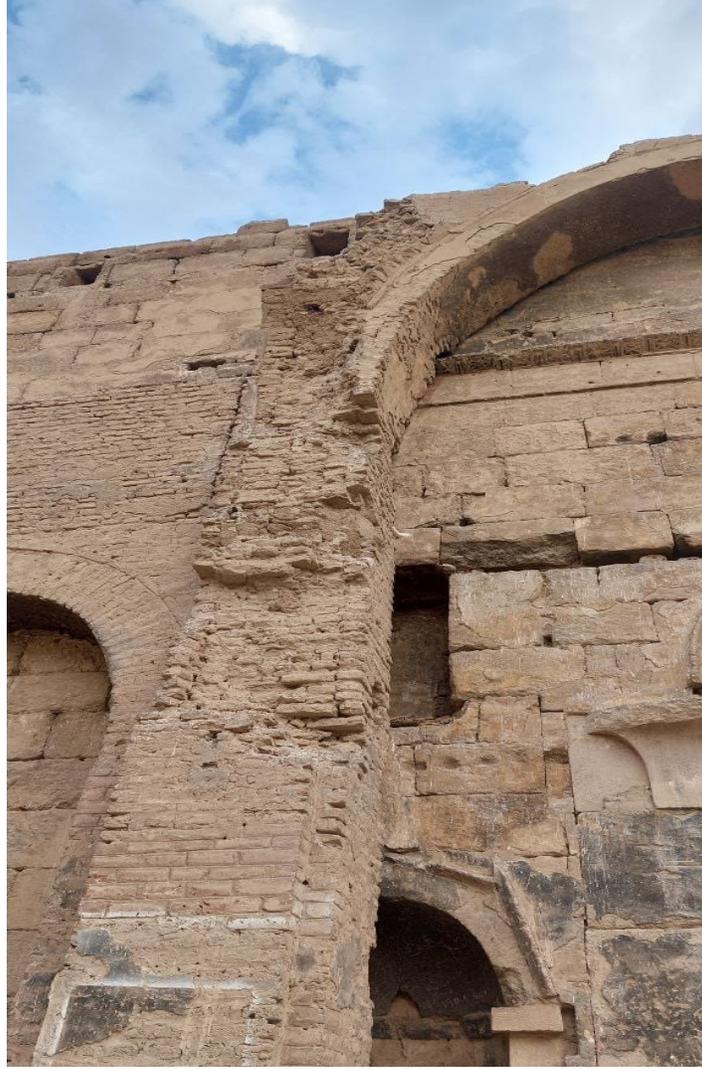
٨. صورہ توضیح مدي تدهور حاله السور بتاريخ ٨ يناير ٢٠٢٢.

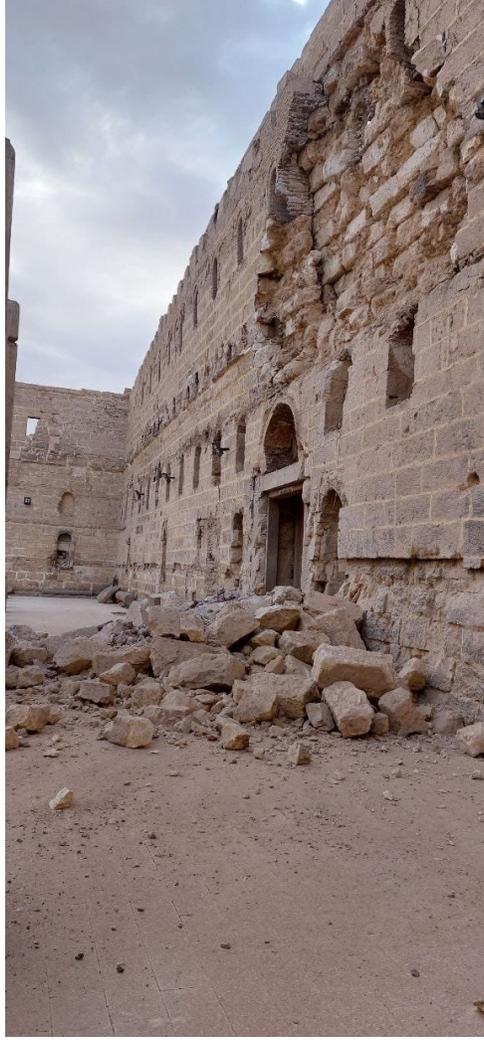
٩. صورہ توضیح مدي تدهور حاله السور و الانهيار بتاريخ ٨ يناير ٢٠٢٢.

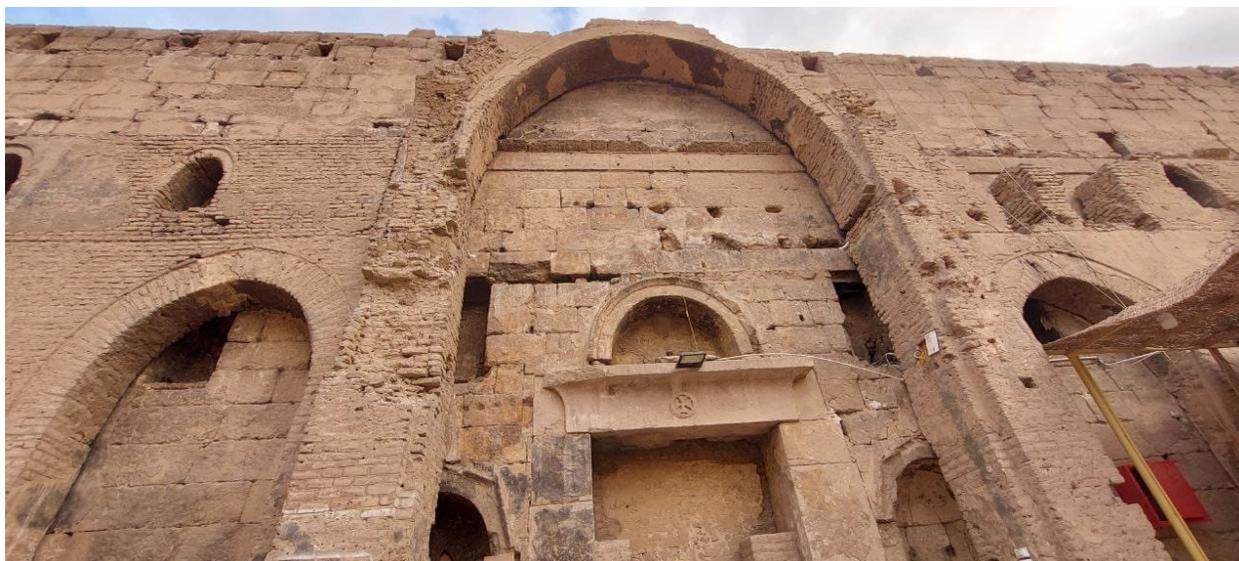
١٠. صورة توضح مدي تدهور حالة السور بتاريخ ٨ يناير ٢٠٢٢.

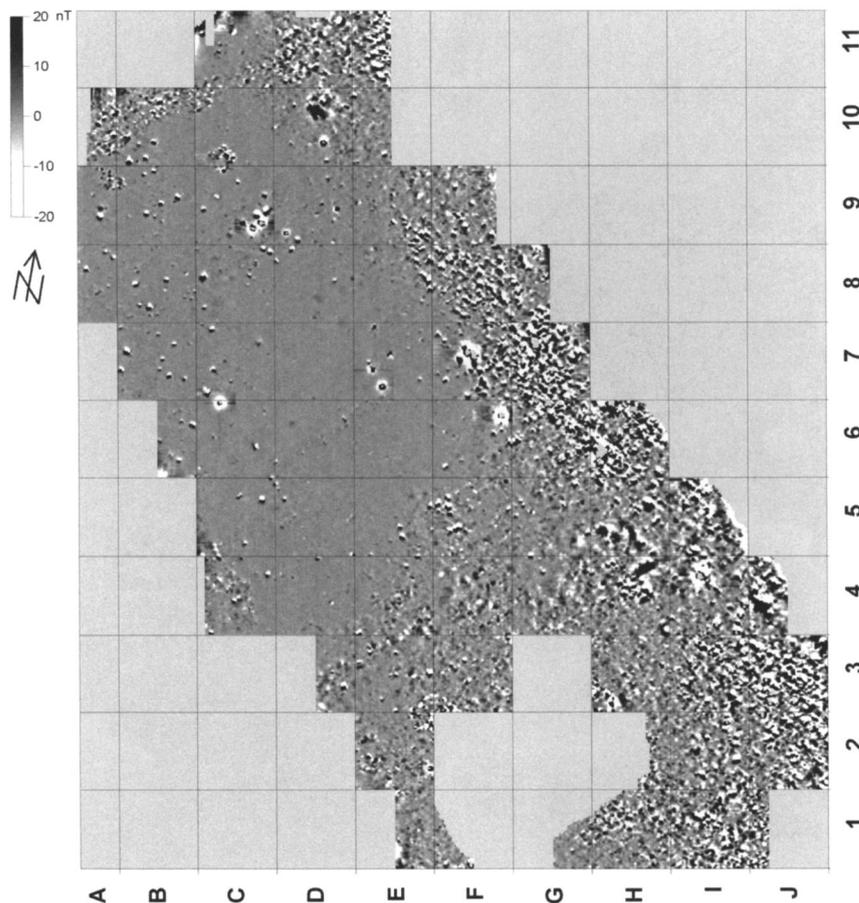
FIG. 5. Magnetic map of Area 1a showing the border between the disturbed and undisturbed zones between squares D₃ and F₆. Sampling rate 0.25 × 0.50 m, interpolated to 0.25 × 0.25 m. Dynamics -16/+24 nT (geophysical map by Tomasz Herbich)

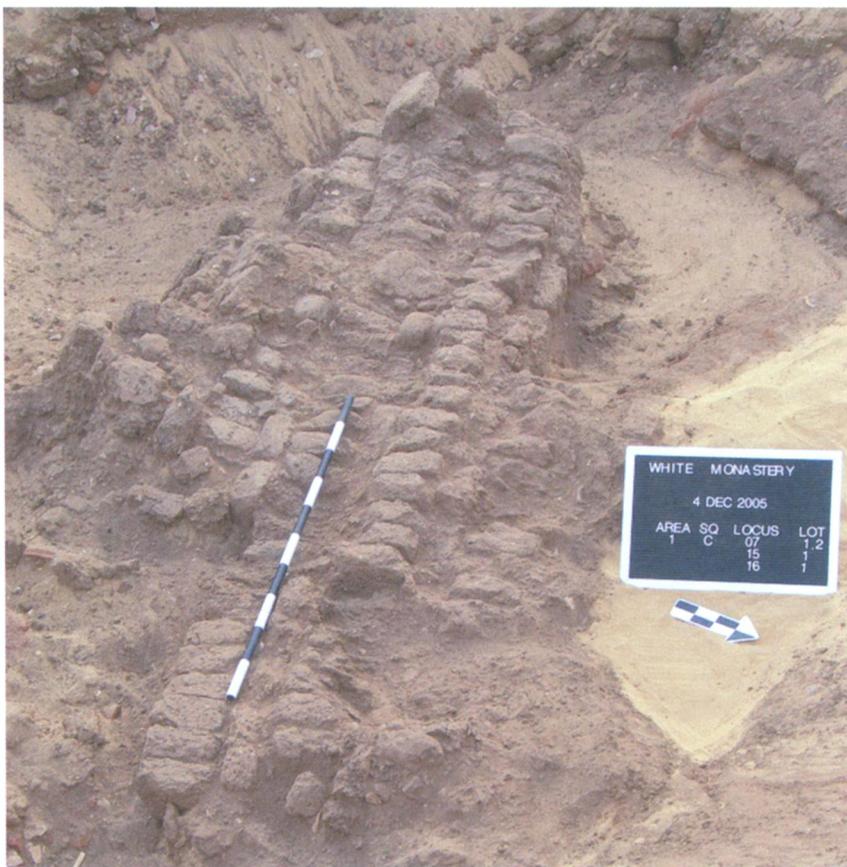
FIG. 7. Excavation in 2005 of Area 1 Unit C, showing poorly preserved mud brick wall discovered when examining magnetic survey results (photo by Darlene Brooks Hedstrom)

of buildings are situated in F₅, E₄, and F₄ (see fig. 5). Excavations began in 2005, after the magnetic survey, and confirmed the presence of mud-brick architecture that was poorly preserved (fig. 7). Another anomaly suggestive of a structure runs along a line between the middle of H₃ and the northwestern corner of G₅. It could represent the edge of buildings of some kind, perhaps at the edge of a walkway or narrow pathway; however,

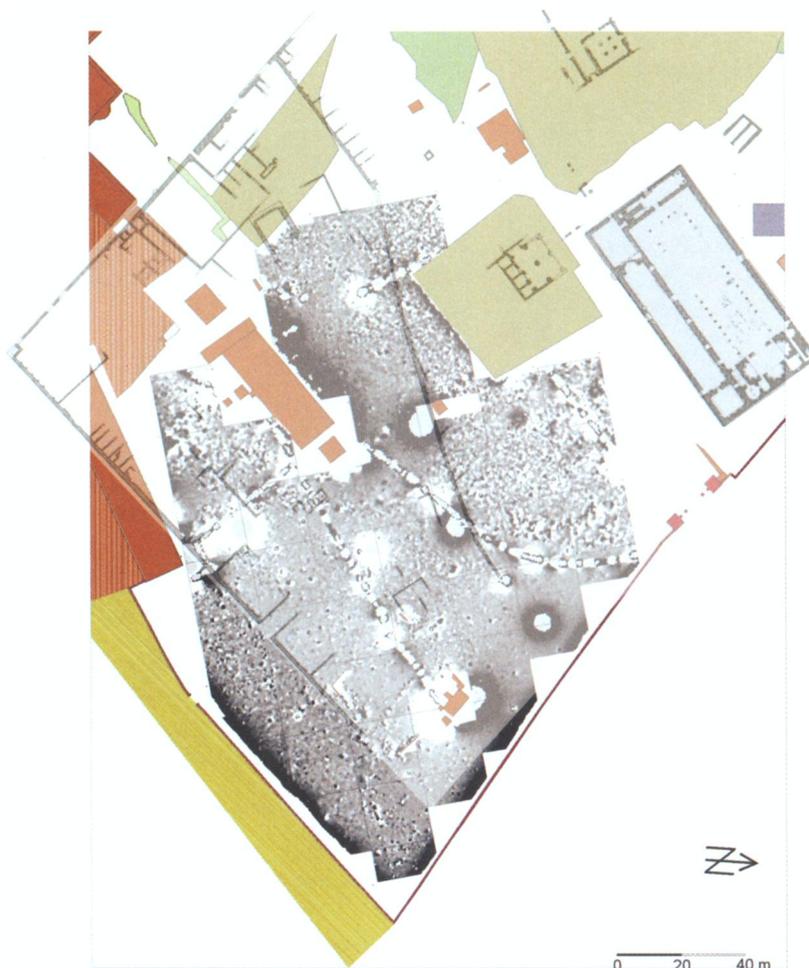
FIG. 10. Area 3 magnetic map with overlay of Grossmann's comprehensive site map, showing alignment of some structures. Plan by P. Grossmann, in Mahmoud Ali Mohamed and Grossmann, "On the Recently Excavated Monastic Buildings in Dayr Anba Shinuda: Archaeological Report," *BSAC* 30 (1991): 53–63 and fig. 1

for little more than the identification of sectors where architectural remains can be expected and should be examined through excavation. Particular areas for further study include the northwestern part of Area 3 immediately adjacent to Unit P and to the south of the church (fig. 9). The anomalies here are probably due to layers of red brick, the same material that was used in the construction of features revealed in Unit P. The high magnetic susceptibility of red brick makes it almost impossible to trace particular walls by separating them from the mud and red brick debris in the fill. By juxtaposing the magnetic data in Area 3 with Grossmann's mapping of those mud-brick architectural remains that were visible on the surface in the 1980s (and expanded in 1991, 2002, and 2003) it is possible to note a connection between the course taken by mud-brick walls (along an E-W line) and the southern edge of the anomalous zone described above (fig. 10).

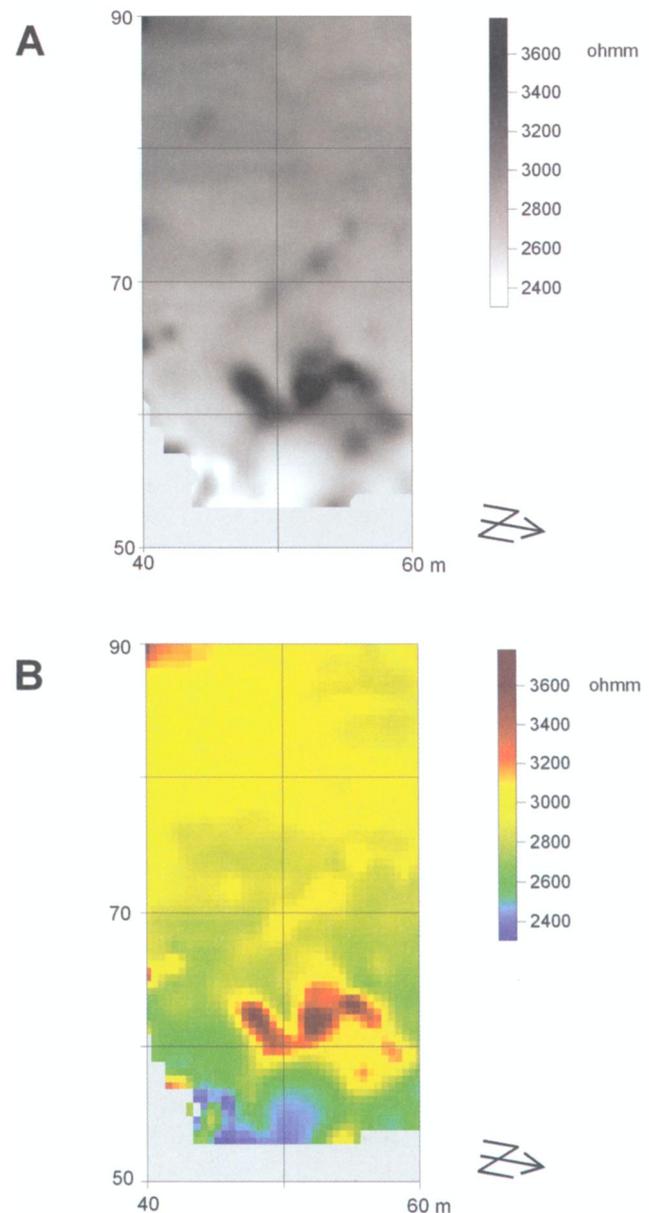
FIG. 11. Area 3 resistivity maps. Resistivity meter RM15. Sampling rate 0.5×1 m, interpolated to 0.5×0.5 m. A: dynamics 2390–3521 ohmm. B: dynamics 2300–3780 ohmm (geophysical map by Tomasz Herbich)

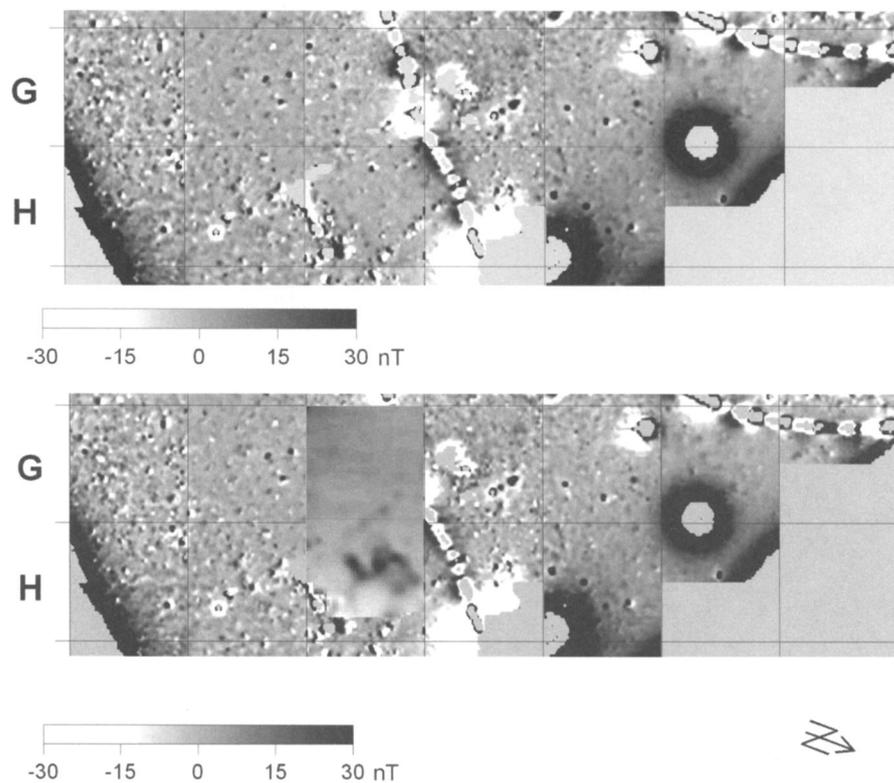
FIG. 12. Comparison of readings from Area 3, sections H₃ and G₃ in magnetic (above) and resistivity (below) surveys, illustrating walls in H₃ discovered in the latter but not the former (geophysical map by Tomasz Herbich)

traces of walls seem to be visible in the subsurface readings. The unsatisfactory results are due to a number of factors, not only the metal objects. For one thing, the mud-brick architecture that was noted must be in a fairly ruinous condition, as readings could not positively record strong wall lines. The fill around several red brick buildings must also contain large amounts of fired-brick debris.²² No actual layouts of architectural features could be traced based on the magnetic prospection results, but the survey has pictured the approximate extent of areas where mud-brick architecture could be expected and those areas where red brick was commonly in use for construction. The small resistivity survey provided better results for recording architectural remains, but the method is very time-consuming. Therefore, test excavation areas are critical to examine the White Monastery's settlement history in these areas.
