السيد المستشار/رئيس هيئة النيابة الادارية

اهمال الدير الأبيض بسوهاج وانهيار أجزاء من الجدار الشمالي

الدير الأبيض - دير الأنبا شنودة - في سوهاج تقرير عن إدارة وتطوير المنطقة 2010

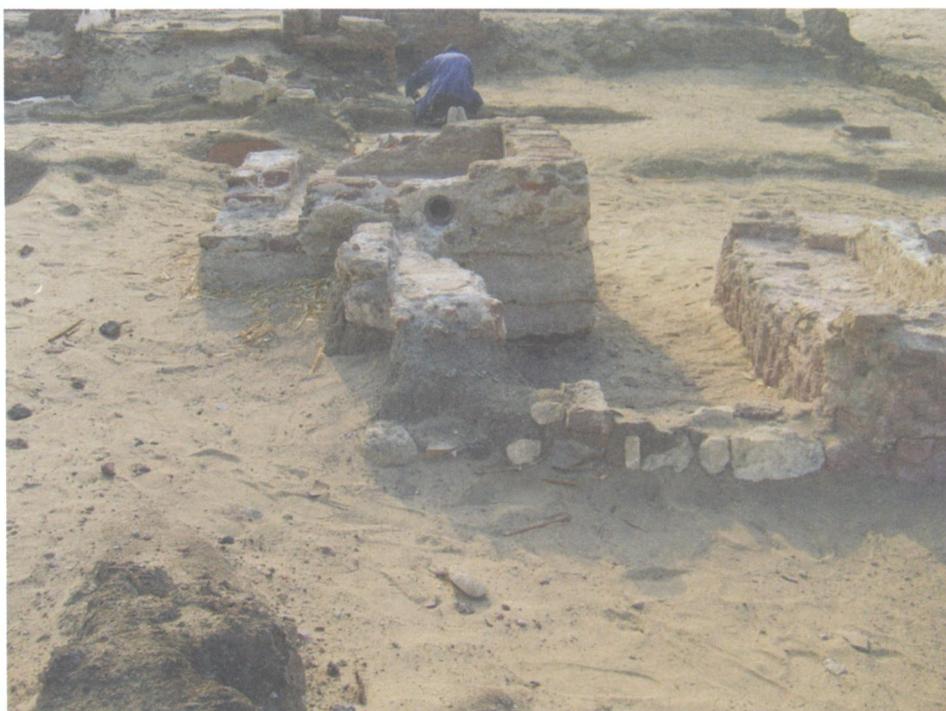
FIG. 15. Plastered holding tank with ceramic channel and supports on the east side of Unit O. View to the southwest (photo by Darlene Brooks Hedstrom)

In 2007, we examined a two-hectare area, Unit Q, and two smaller areas, Unit N (west of the largest spoil heap) and Unit O (northwest of the spoil heap).²⁴ In attempting to identify the various structures in Unit Q, we have built upon Grossmann's foundation for understanding the buildings and their possible relationships to each other. It is worth remembering that the spoil heap, made during the clearing of Unit Q in the 1980s, artificially divides the terrain. Therefore, the view that we have of the site's landscape, with a large mound in the north, is distorted. We know from surface evidence that the remains of the monastery continue underneath this mound, and they are most likely connected to buildings and other facilities, such as plastered tanks and ceramic piping, to the north in Unit O (figs. 14–15). A comparison of the maps and recorded elevations with

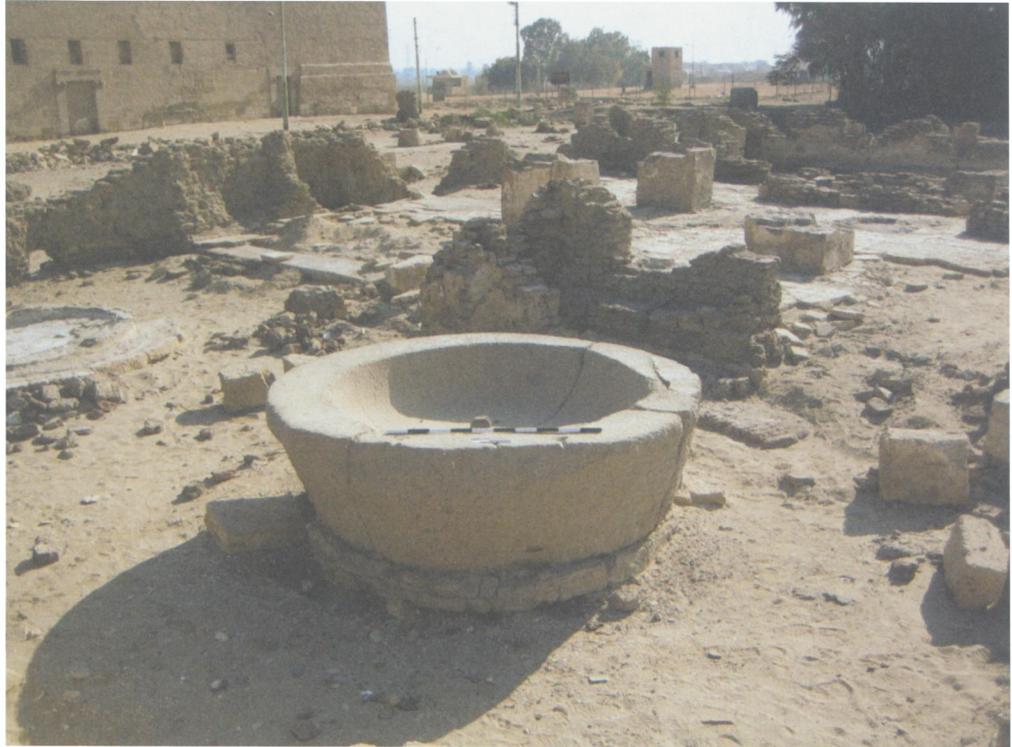
FIG. 20.
Unit Q, north and south mills, view to the south (photo by Gillian Pyke)

The south mill is in the west end of the first unroofed area and has enough surrounding space for it to have been used for flour production (fig. 19). Another mill, located in an apparently separate room directly north and associated with the “L-shaped building,” as described by Grossmann, is adjacent to a vat made of mud bricks and plaster (figs. 20–21). The north mill and its associated vat may be part of an oil press facility. Olive oil production requires two areas: one for crushing and one for pressing.⁴⁷ The mill includes a Roman *trapetum*, or massive stone basin, that would have held rotating convex crushers attached to a wooden framing device, which individuals could push, thereby crushing the olives. The proximity of the mill to the vat suggests that this container may have been a collection area for olive oil. Although it was previously thought that both large stone mills were used for flour, there is not enough space around the north mill for this purpose. The smaller, circular vat, adjacent to the north mill, has channels for the oil to move out of the container to a collection area to the west.⁴⁸ The south mill, which

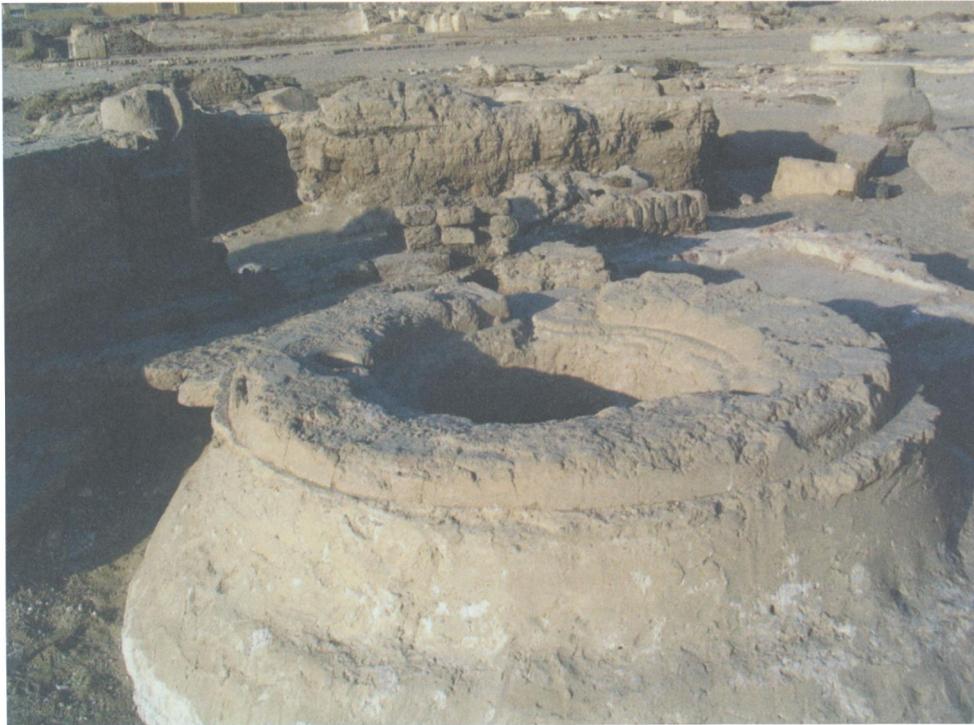
FIG. 21.
Vat to collect oil in
food production area.
View to the west
(photo by Darlene
Brooks Hedstrom)

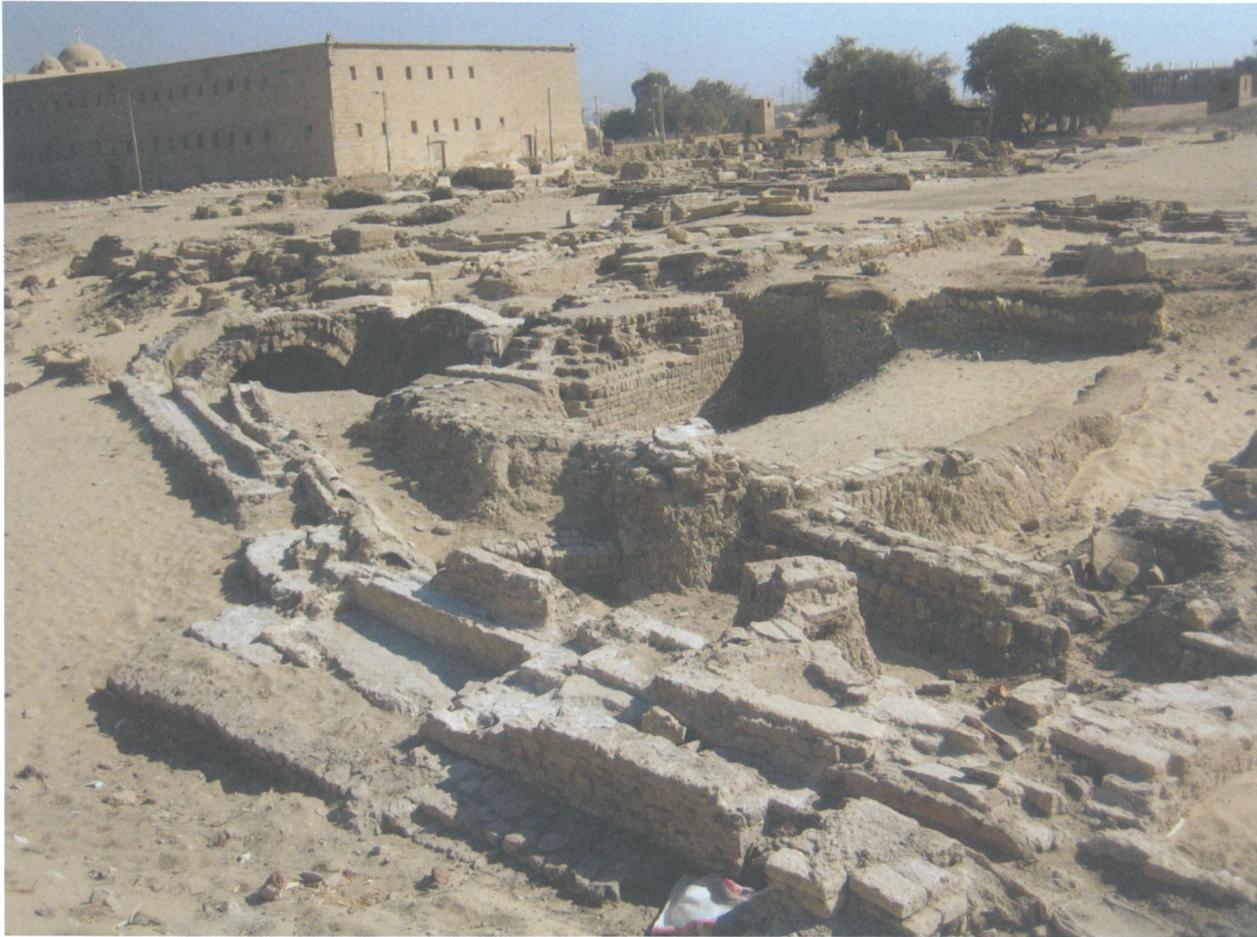
FIG. 23. Unit Q, view to east of the water distribution system with channels leading to the well of Shenoute (photo by Darlene Brooks Hedstrom)

transfer of water (figs. 23–25). Grossmann has already commented on the similarities between the plan of the well and that of the central unit of the triconch in Shenoute’s church. Based upon these parallels and the care used in the construction of the well, Grossmann has proposed that it dates to the time of Shenoute.⁷¹ The importance of a well for the community is substantiated by the *Life of Shenoute*.⁷² In this text, the

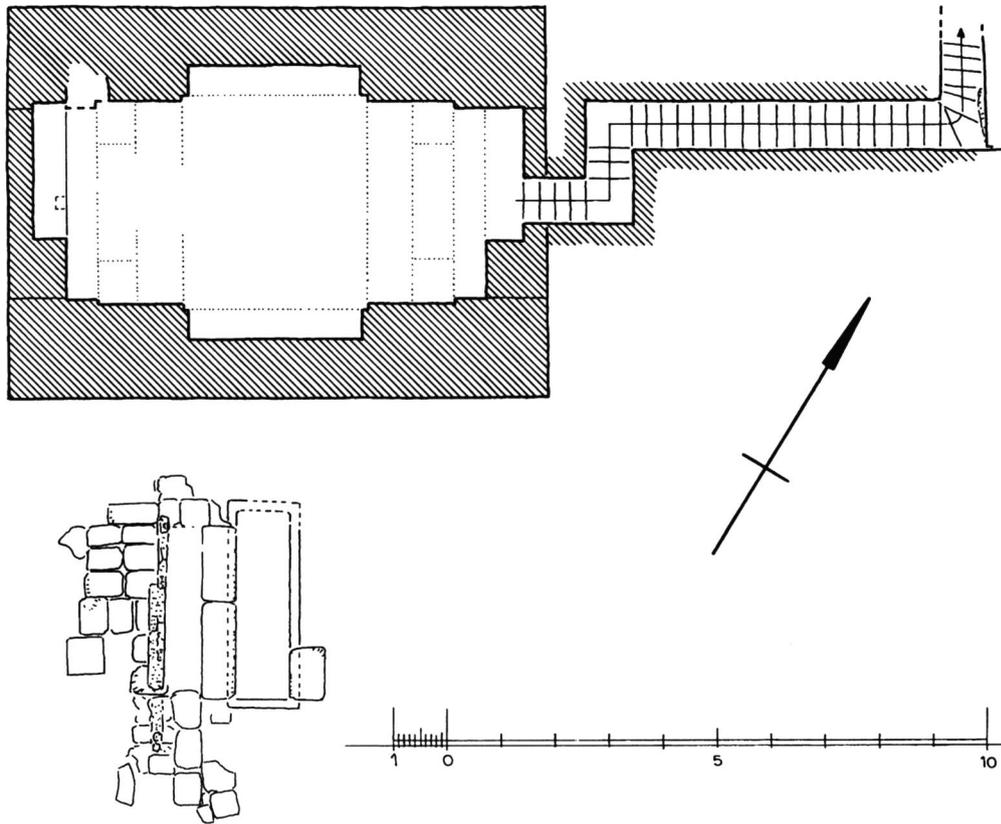
FIG. 24. Plan of the well at the White Monastery, showing the staircase on the east and the two saqiya extensions, located on the east and west sides (plan by P. Grossmann, in *DOP* 63 [2009]: 187, fig. 22)

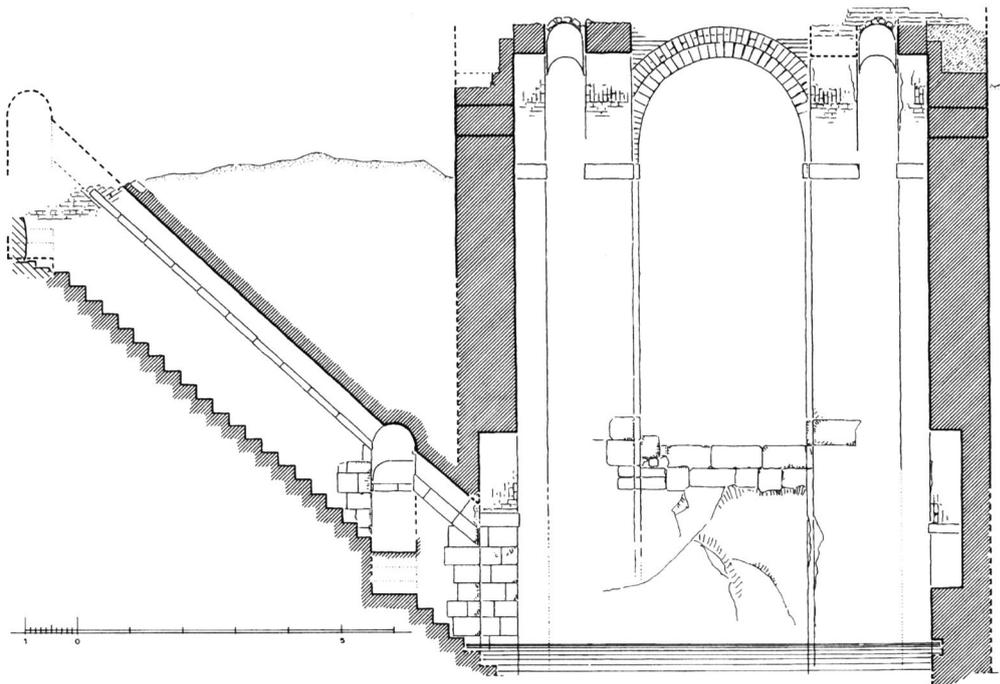
FIG. 25. Profile of the well showing two saqiya extensions flanking the arch on the east and west (left and right) sides (plan by P. Grossmann, in *DOP* 63 [2009]: 187, fig. 21)

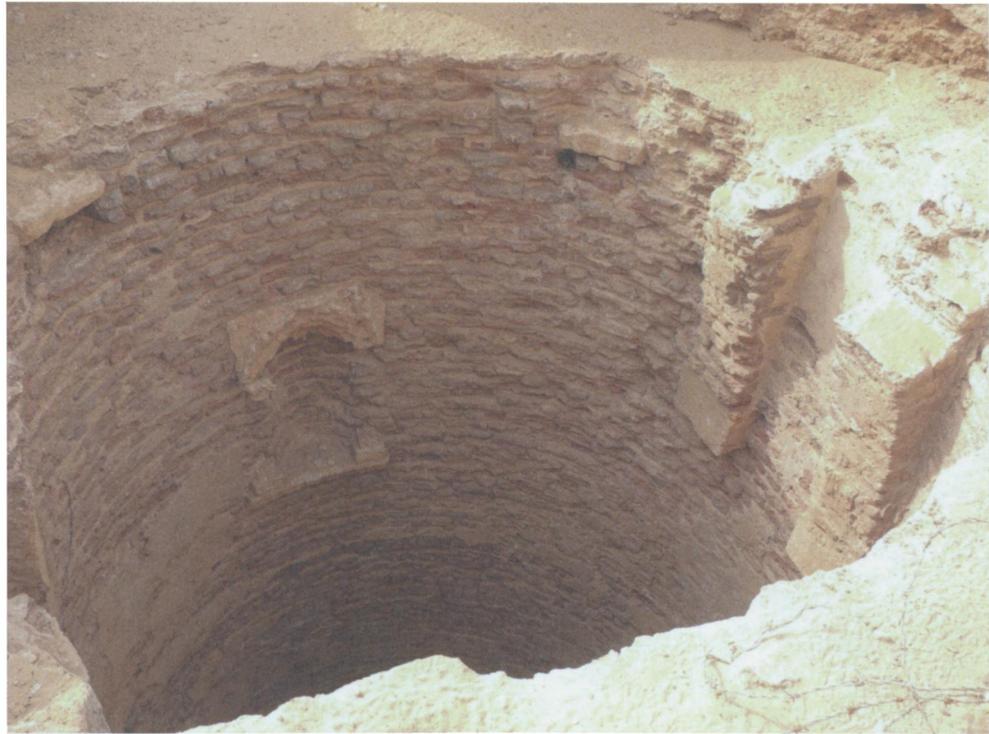
FIG. 26. Well at the Red Monastery, view northwest. Note one of the two decorative stone niches lining the walls (photo by Darlene Brooks Hedstrom).

construction of a smaller well is mentioned.⁷³ It is also interesting that a similar plan is visible in the well at the nearby Red Monastery, also part of Shenoute's federation, although it differs from the one at the White Monastery in that it has two high decorative niches, lacks a dedicated staircase, and held only one *sāqīya* (fig. 26).

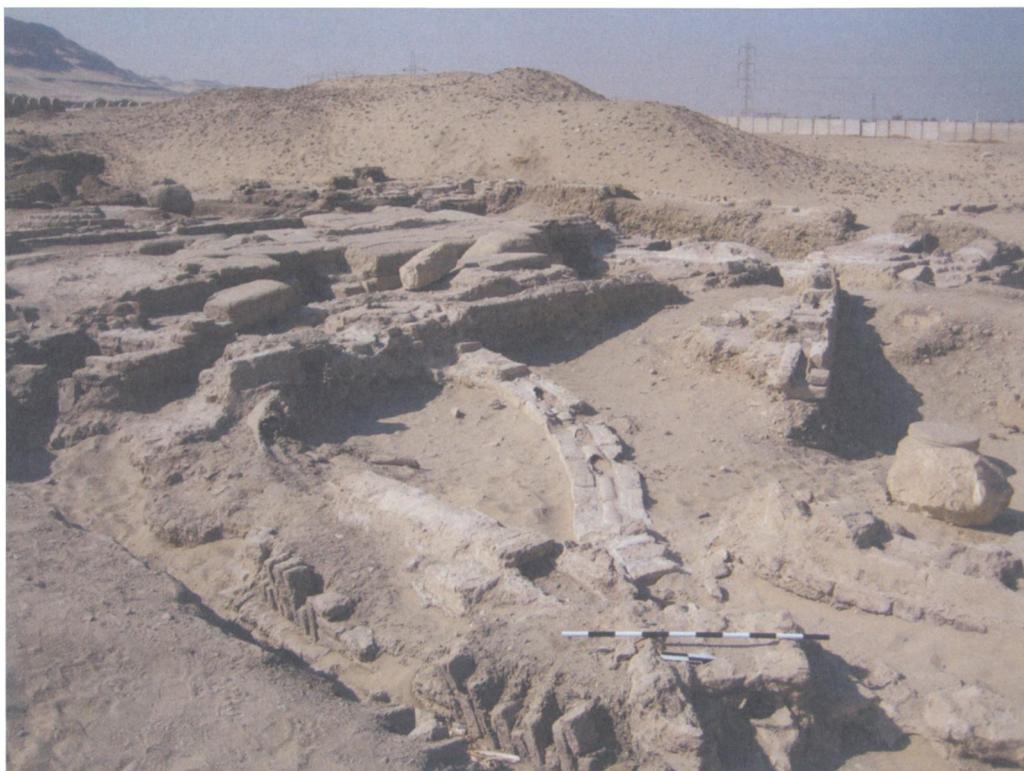
FIG. 28. Ceramic and red brick channels in White Monastery water installations, view to northwest (photo by Dawn McCormack)

At both the White and Red Monasteries, extensive ceramic piping, encased in plaster and brick channels, extends from the wells across both sites (figs. 27–31).⁷⁴ In our survey map of the White Monastery, we included some of the ceramic piping that connects inspection tanks. These tanks are small rectangular containers with covered openings that allowed access to the subsurface piping, in order to facilitate the resolution of any problems with the movement of the water throughout the monastery. It is apparent that these

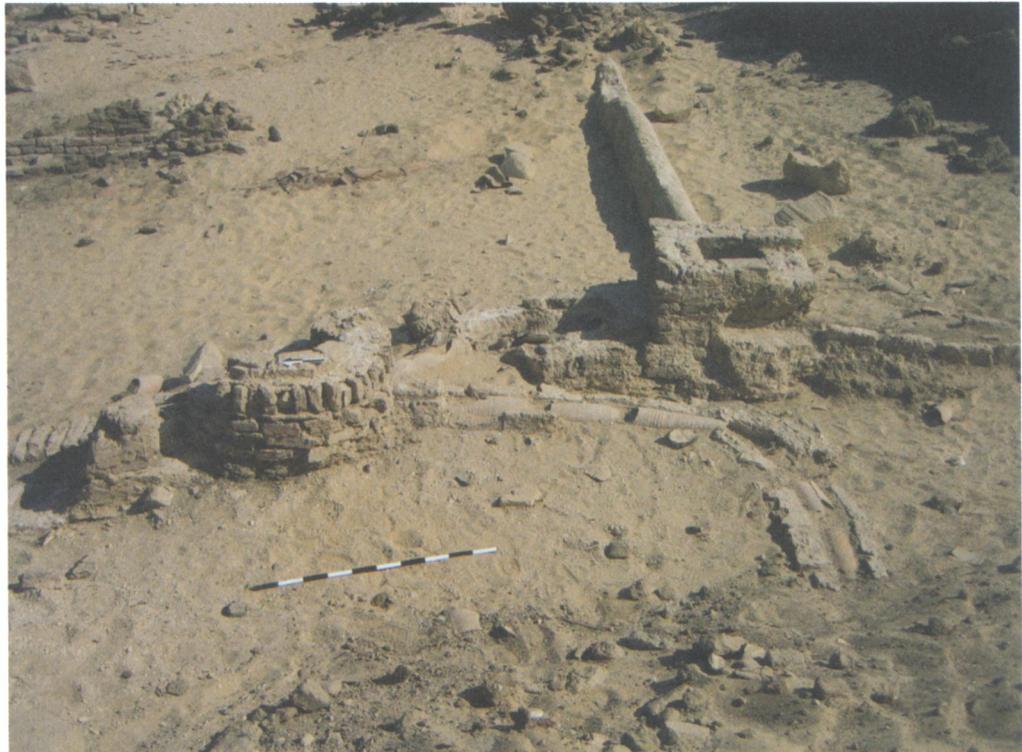
FIG. 30.
Inspection stone
tank and plaster
platform at Red
Monastery (photo
by Darlene Brooks
Hedstrom)

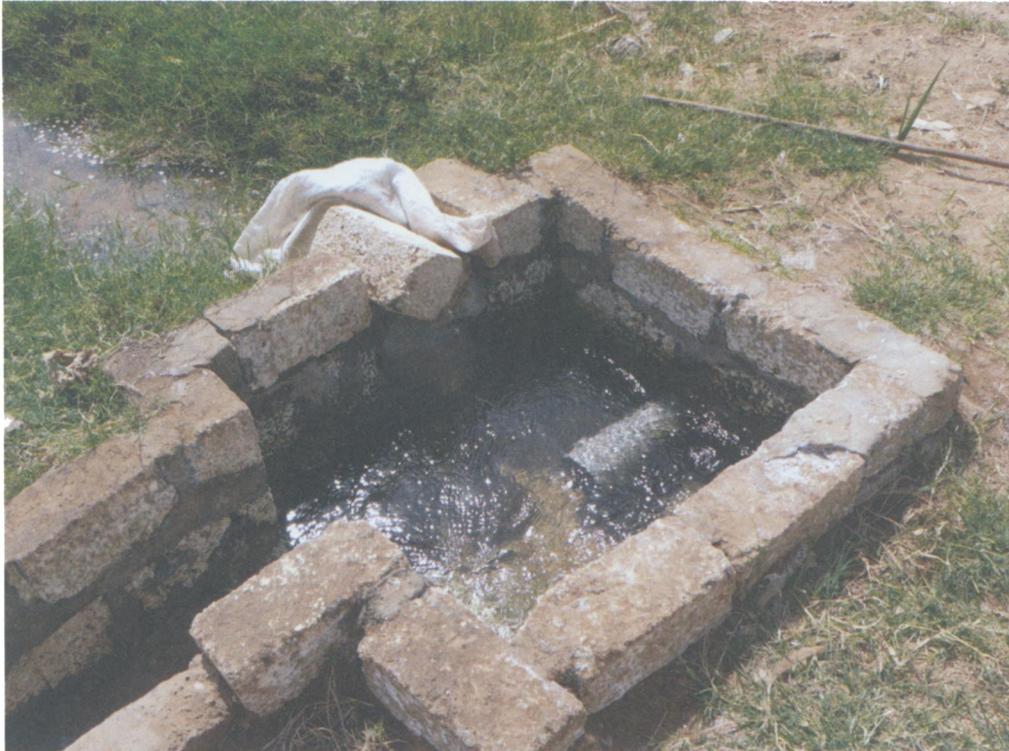
FIG. 31.
Modern inspection
tanks in use for
irrigated fields in
Sohag (photo by
Darlene Brooks
Hedstrom)
